United States Department of the Interior
National Park Service
NATIONAL REGISTER OF HISTORIC PLACES
CONTINUATION SHEET

PALAFOX HISTORIC BUSINESS DISTRICT
PENSACOLA, ESCAMBIA COUNTY, FL
DESCRIPTION

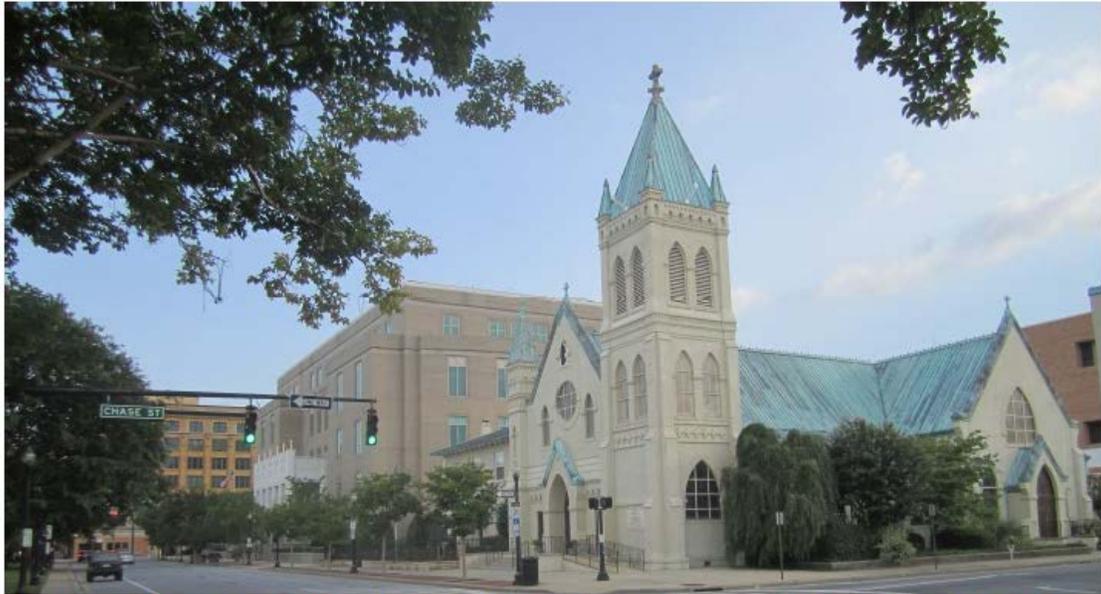
33 North Palafox Street, Palafox Historic District Pensacola, Escambia County, FL. Cynthia Catellier, 07/30/2011, Location of original with photographer, Viewing southwest, Photo 19 of 50

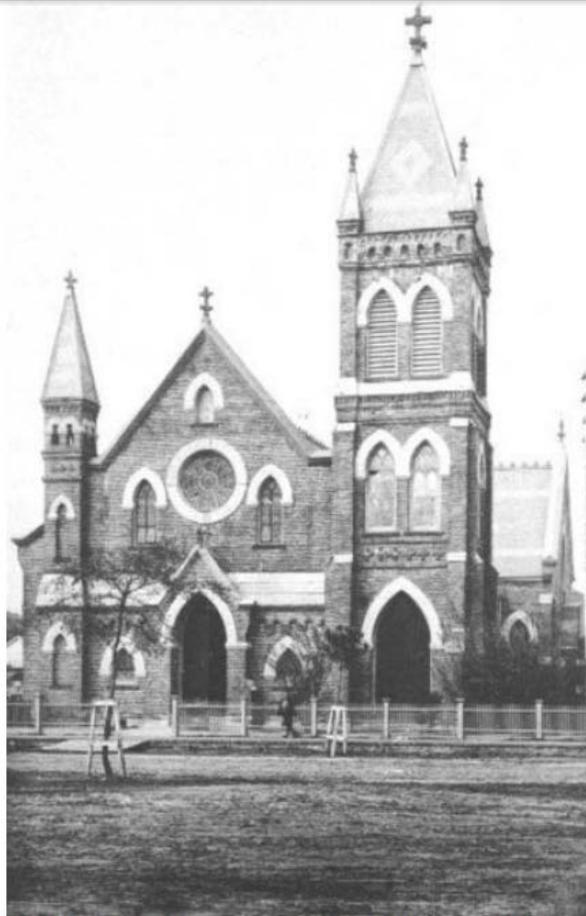
33 North Palafox Street, Palafox Historic District Pensacola, Escambia County, FL. Photographer unknown, circa 1894, Location of original Florida Memory Project PR08496, Viewing west, Photo 20 of 50

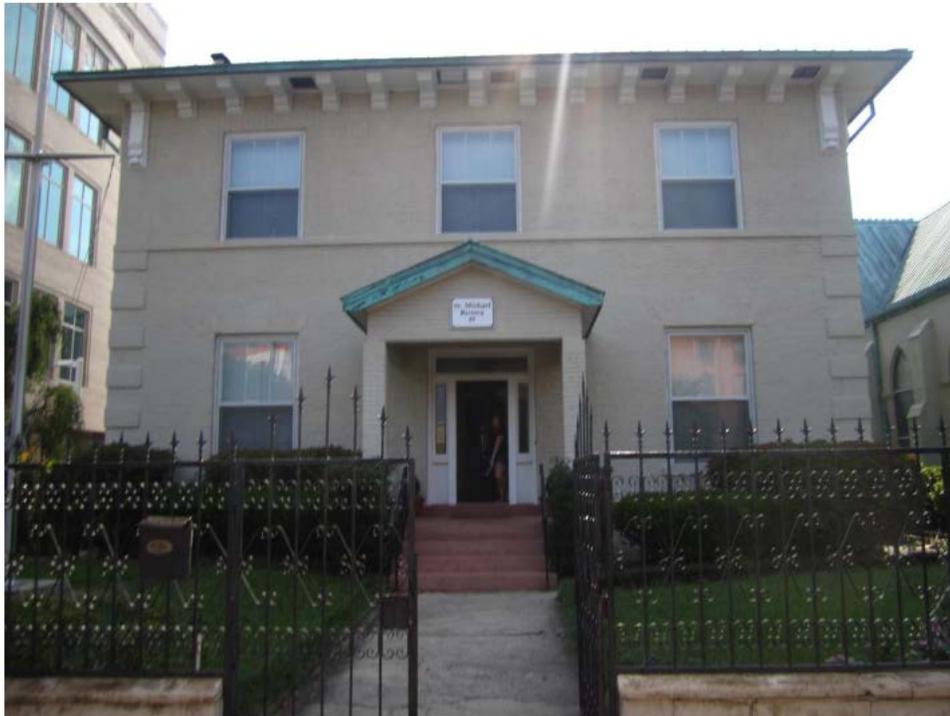
19 North Palafox Street, Palafox Historic District Pensacola, Escambia County, FL. Cynthia Catellier, 07/30/2011, Location of original with photographer, Viewing west, Photo 24 of 50

Built c.1912, the two-story Georgian-Revival style **St. Michael's Rectory** at 19 North Palafox Street (ES01176) has been in continuous use as the rectory for St. Michael's Catholic Church since its construction (Photo 15). The building, with noted Italianate influence, has a low-pitch hip roof with an exaggerated overhang supported by brackets. Elongated consoles support the overhang at corners. A narrow brick chimney pierces the south roofline. A gable-topped front portico supported by brick columns protects the front door, flanked by three-quarter height sidelights and a full width transom. Quoins line the sides of the masonry building and a belt course lies just below the second story windows and wraps around the side elevations. The first story windows are topped with keystone arches, painted to match the exterior brick. Historic images show the building to be unpainted brick, with one-over-one double-hung wood sash windows. The building currently reflects three-over-one replacement vinyl windows. The building currently reflects three-over-one replacement vinyl windows.
